Case Study: Resolving N2 Bus (RS-485) Issues on an existing S4 Open: BACnet-N2 Router installation.

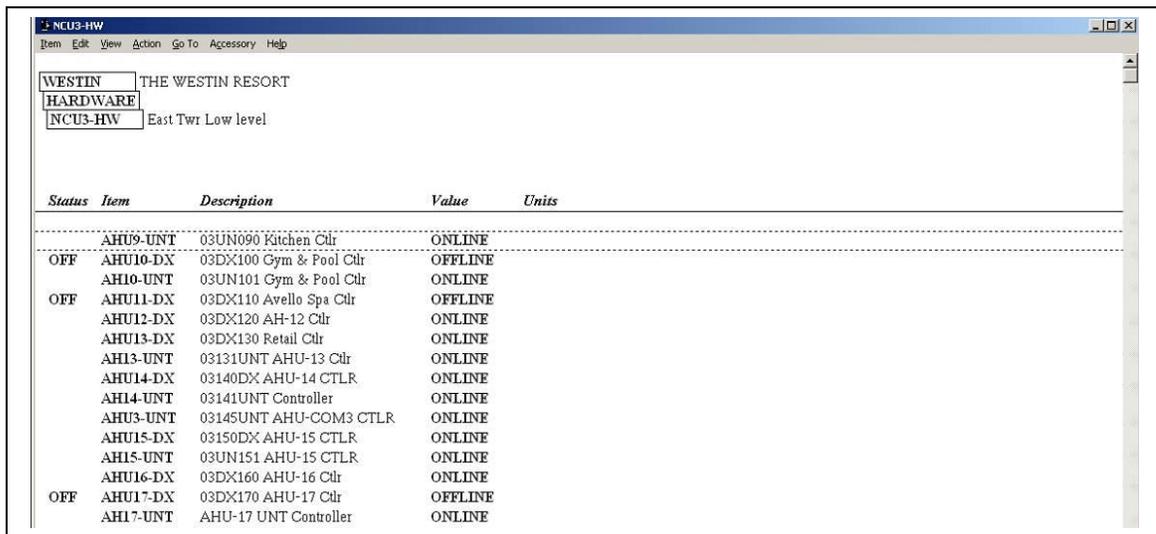
1. On the four installed S4 systems, the status reported whether the N2 devices were on / offline by the toggling of the NAE. The devices would randomly go offline for up to 20 minutes before toggling back online. One could not predict which devices would be the next to toggle their state.
2. Moreover, when a device was offline, attempts by the NAE controller to send commands/schedules and set points failed.

Status	Item	Description	Value	Units
	AHU9-UNT	03UN090 Kitchen Ctr	ONLINE	
OFF	AHU10-DX	03DX100 Gym & Pool Ctr	OFFLINE	
	AHU10-UNT	03UN101 Gym & Pool Ctr	ONLINE	
OFF	AHU11-DX	03DX110 Avello Spa Ctr	OFFLINE	
	AHU12-DX	03DX120 AH-12 Ctr	ONLINE	
	AHU13-DX	03DX130 Retail Ctr	ONLINE	
	AHU13-UNT	03131UNT AHU-13 Ctr	ONLINE	
	AHU14-DX	03140DX AHU-14 CTRL	ONLINE	
	AHU14-UNT	03141UNT Controller	ONLINE	
	AHU3-UNT	03145UNT AHU-COM3 CTRL	ONLINE	
	AHU15-DX	03150DX AHU-15 CTRL	ONLINE	
	AHU15-UNT	03UN151 AHU-15 CTRL	ONLINE	
	AHU16-DX	03DX160 AHU-16 Ctr	ONLINE	
OFF	AHU17-DX	03DX170 AHU-17 Ctr	OFFLINE	
	AHU17-UNT	AHU-17 UNT Controller	ONLINE

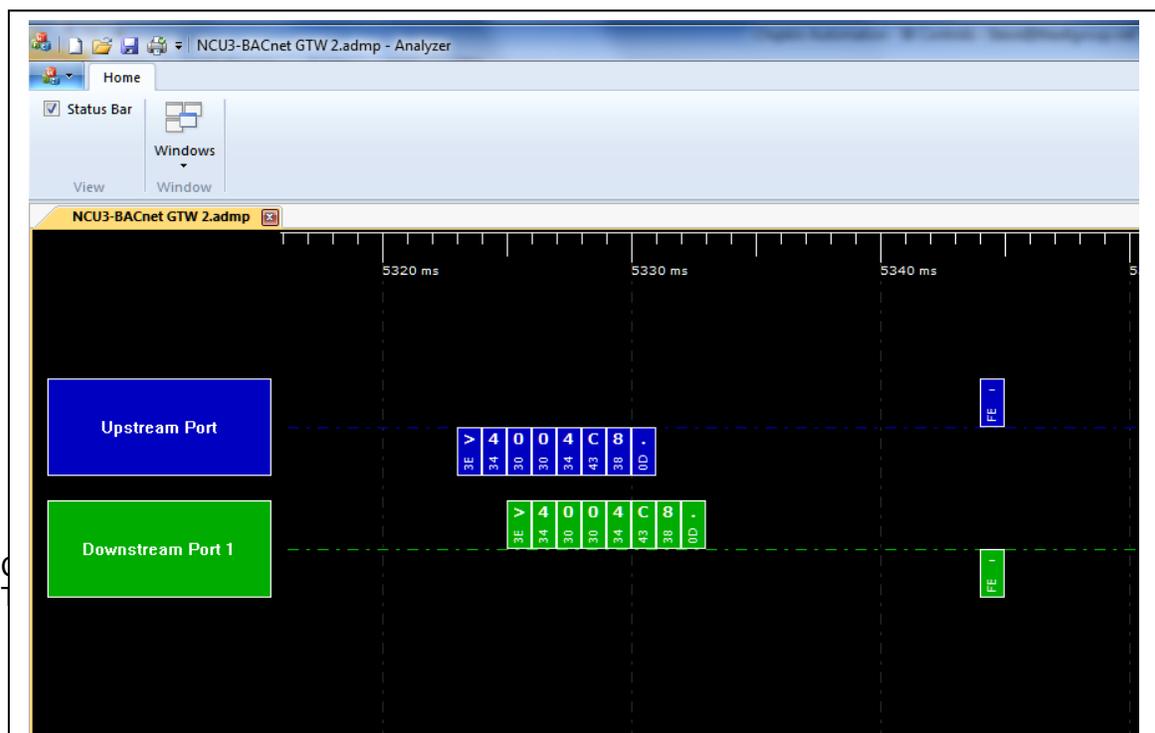
Looking at the image above of a COS poll request for the device at 0x40, we can see the N2 transaction starts with a >. The response that follows is invalid as it should start with either A (Ack) or N (Nak). A single character A is acceptable in this case; however, that is not what we are seeing. This could be garbling on the line, it could be an invalid response being generated from this address, it could be another device responding when it shouldn't and stepping on the A (simple one character Ack) response, or it could be a spurious response from another device.

Based on everything else that we saw, we think this started out as a valid response and became garbled due to N2 bus quality problems.

As we see, there is a long delay on the bus while the NCM is waiting for the proper response. In essence, it never happens. Then we see the NCM trying again and getting a valid response.

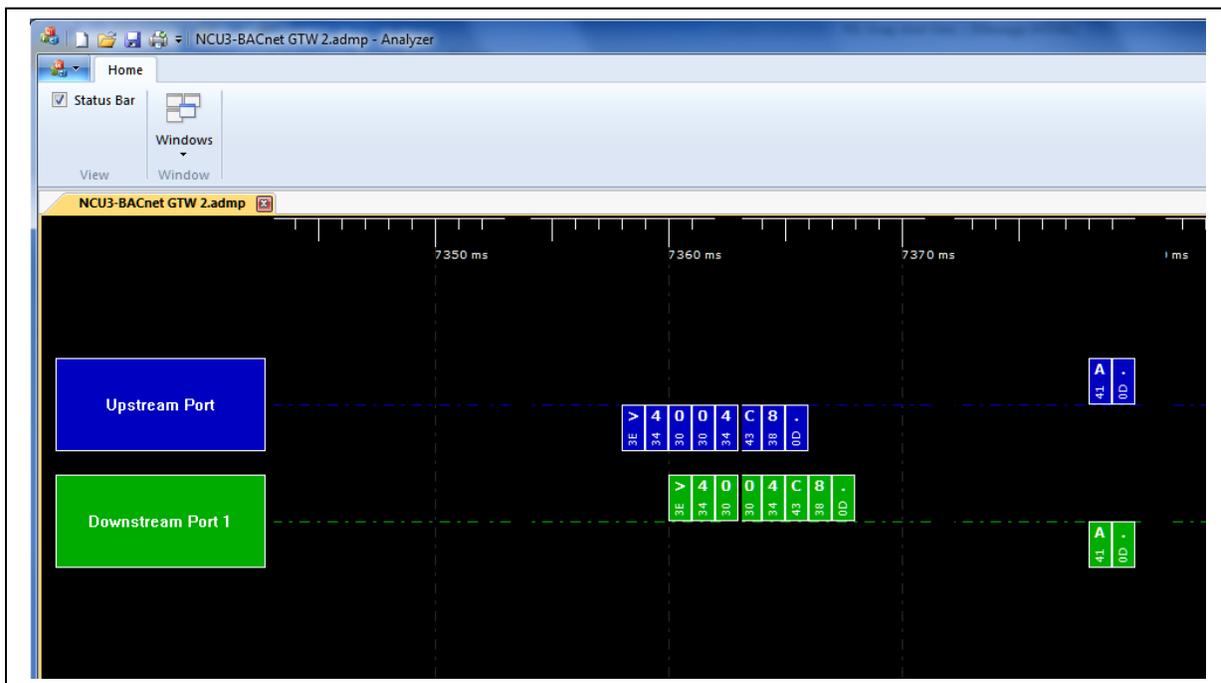
In general, what we are seeing is a completely normal operation of the N2 router, it is:

- Passing transactions from the NCM to the N2 bus and routing the responses back.
- Trying to bring offline devices back on line. I've seen both successful and unsuccessful attempts at this.
- Most of the time we see successful point level transactions or COS polls at the device level. In a few cases we have observed timeouts where the N2 Router is waiting for an N2 device to respond which it never does.
