Case Study: Resolving N2 Bus (RS-485) Issues on an existing S4 Open: BACnet-N2 Router installation.

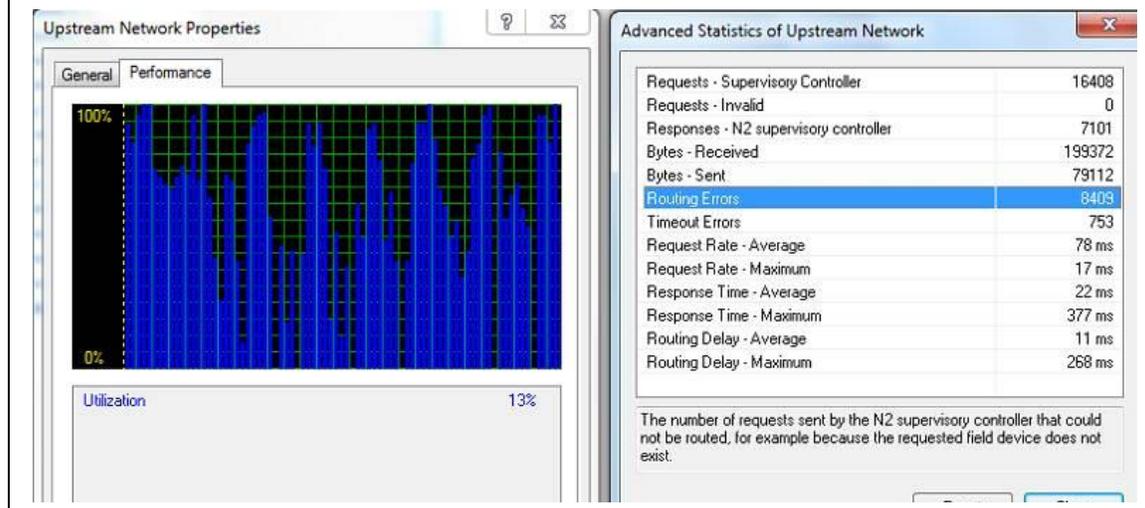
Recently, a large number of timeouts and routing errors on our Metasys system have alerted us to a problem. The spare capacity on the upstream network shows that the Metasys controller is leaving the S4 router space to blend in message on the trunk for the purposes of the BACnet interface.
